Water Damage Cleaning In Tunbridge Wells

Kent, United Kingdom

CASE STUDY

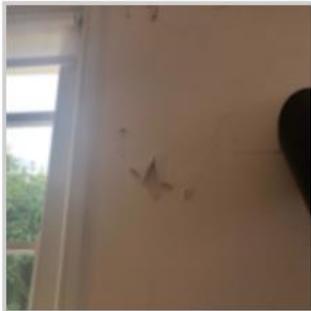
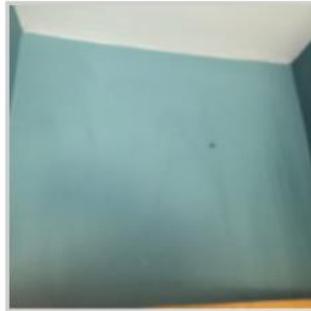
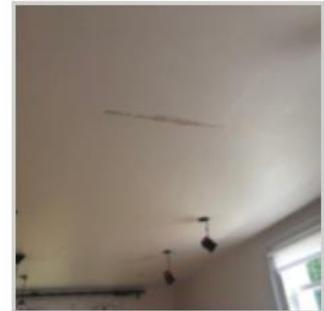
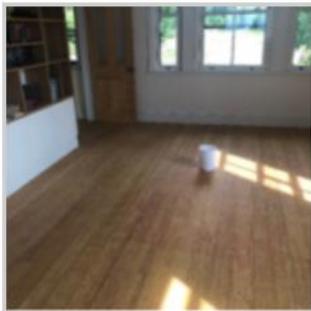
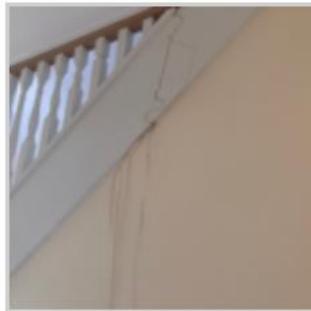
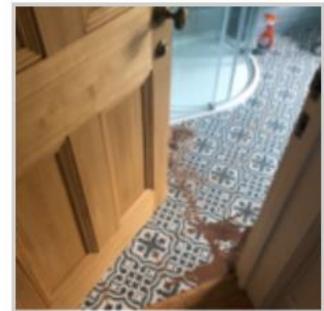
A water pipe in the loft burst over the weekend and it is assumed that water was running at a rate of 32L/min for approximately one day. There was damage to both the upper and lower floor which required attention.

There was water damage and cracked paint to the ceiling in the kitchen/sitting room and blown plaster on the sitting room walls. Upon our attendance, water was still present in the void in the kitchen/sitting room. The flooring to this room was also damaged.

Water damage – including staining – was present in the entrance hall, including the staircase, bannisters and landing. Architraves around the house were also affected, as were various bedroom walls and the loft hatch. Debris from the loft was found on the bathroom floor.

After our initial assessment, we returned to Tunbridge Wells to carry out the work identified, which included the removal of all affected skirting and architrave across both floors.

The damaged flooring on the ground floor needed removing, which required cutting round built-in units and kitchen units. The carpets and underlay on the first floor also required removal.

The compromised ceiling in the kitchen/sitting room was removed, along with the Rockwool insulation. The flooring in the loft was also lifted in order to remove the affected insulation.

The affected walls and surfaces within the property were sanitised to reduce the chance of mould germination and a bespoke drying regime was put in place to assist in the drying out of the building.

Pressure dryers were installed to the lath and plaster walls in the affected rooms and desiccant dehumidifiers in the areas that didn't require pressure drying.
