Grade 2 Listed Building: Fire, Flood and Drying for The Law Society

CASE STUDY

London, United Kingdom

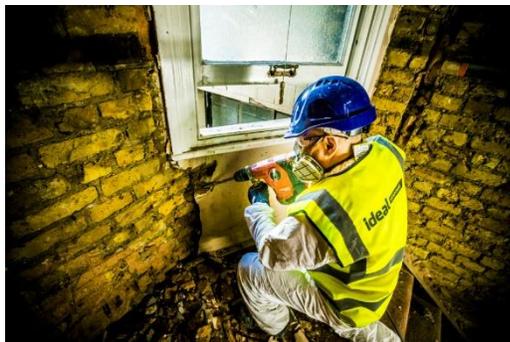
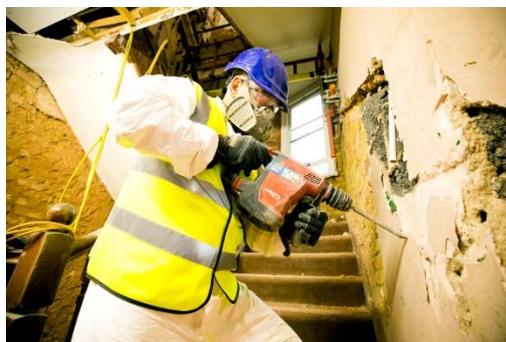
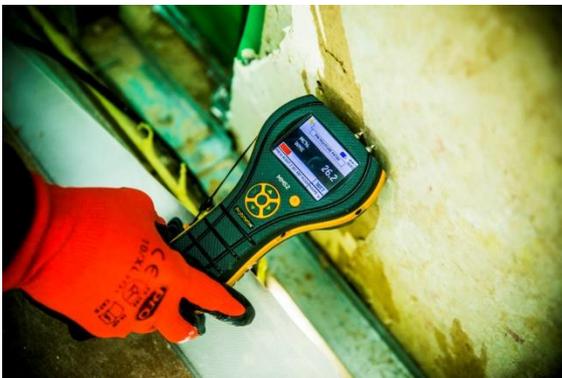
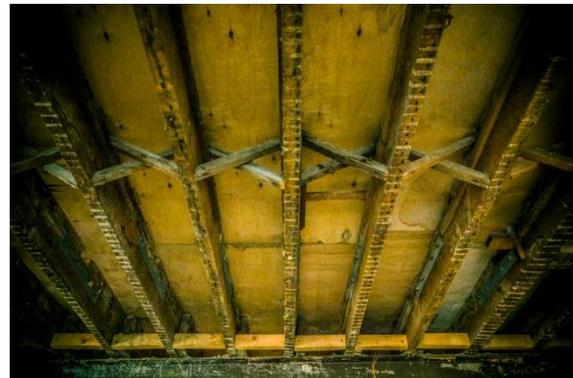
Phase 3: Mould remediation

The fire service had put out the fire with water saturation. This, coupled with the lack of roof and the time of year, had led to a serious mould problem throughout the building that needed to be addressed urgently. Mould can cause serious health problems if left untreated, on top of the unpleasant look and smell of it.

This phase in itself was conducted in 4 different stages. First of all, our team of technicians used their industrial vacuums, fitted with HEPA filters, to remove all of the surface mould. This ensured that there were no mould spores in the air, creating a safe environment.

Next, all of the affected surfaces were given a wash-down with our specially formulated solutions. Any mould that remained after the vacuums were used would be removed here.

Once that had dried, we treated the surface with one coat of our specially formulated fungicidal barrier. This was manually brushed on to all of the affected areas. The solution soaked into the surface that the mould was growing on and killed the roots. It also acted as a protective barrier against any further fungal growth.

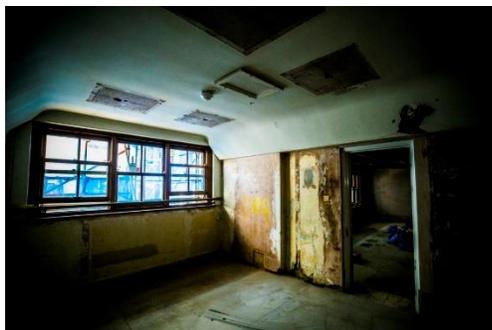
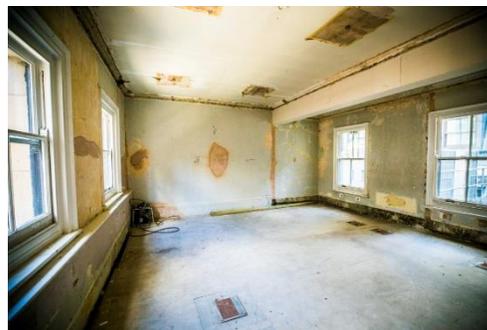
Phase 4: Drying

The building needed to be dried completely, due to the high saturation of water from the extinction of the fire. The drying needed to be completed over many floors and all over the building, so needed to be done in a targeted fashion. Multiple dryers were installed across the building, with our technicians on hand around-the clock to monitor all of the equipment involved.

With around 200 pieces of drying equipment being used, it was imperative that it was all working at all times. We calculated that if one floor of drying went down at any time, it would cost around £3000-£4000 worth of delays to the programme. The drying phase was so important to the success of the entire job.
