# Flood Damage Clean-up in Hertfordshire

CASE STUDY

Hertfordshire, United Kingdom

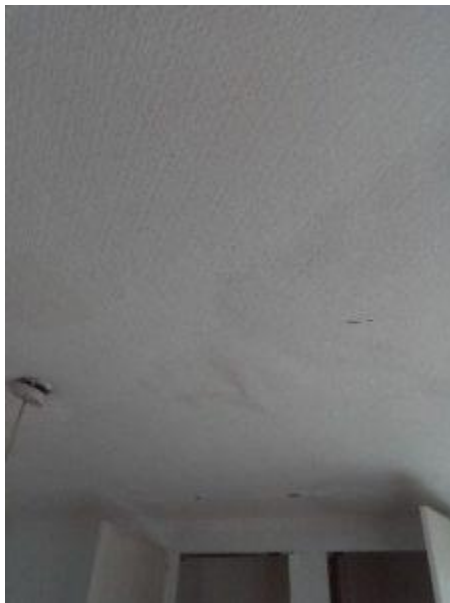
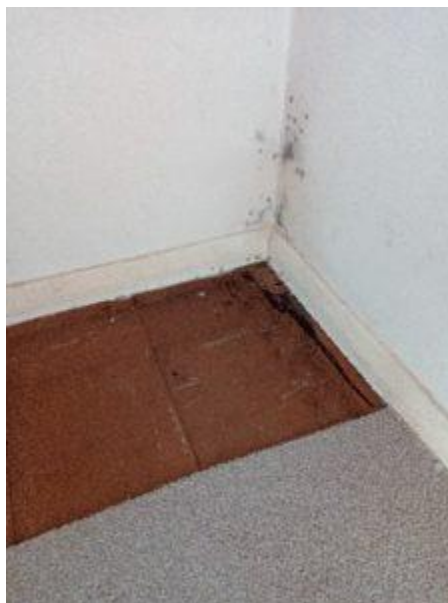
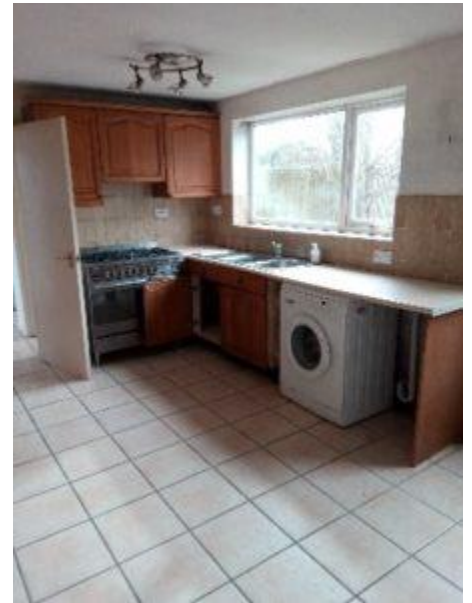
We were called to a property in Kings Langley, Hertfordshire, following an escape of water after the water tank – located in the loft – burst. Both the ground floor and first floor were badly affected, with the majority of the damage isolated to the rear of the property. Sample points in this area read 100% WME, meaning that the materials are completely saturated.

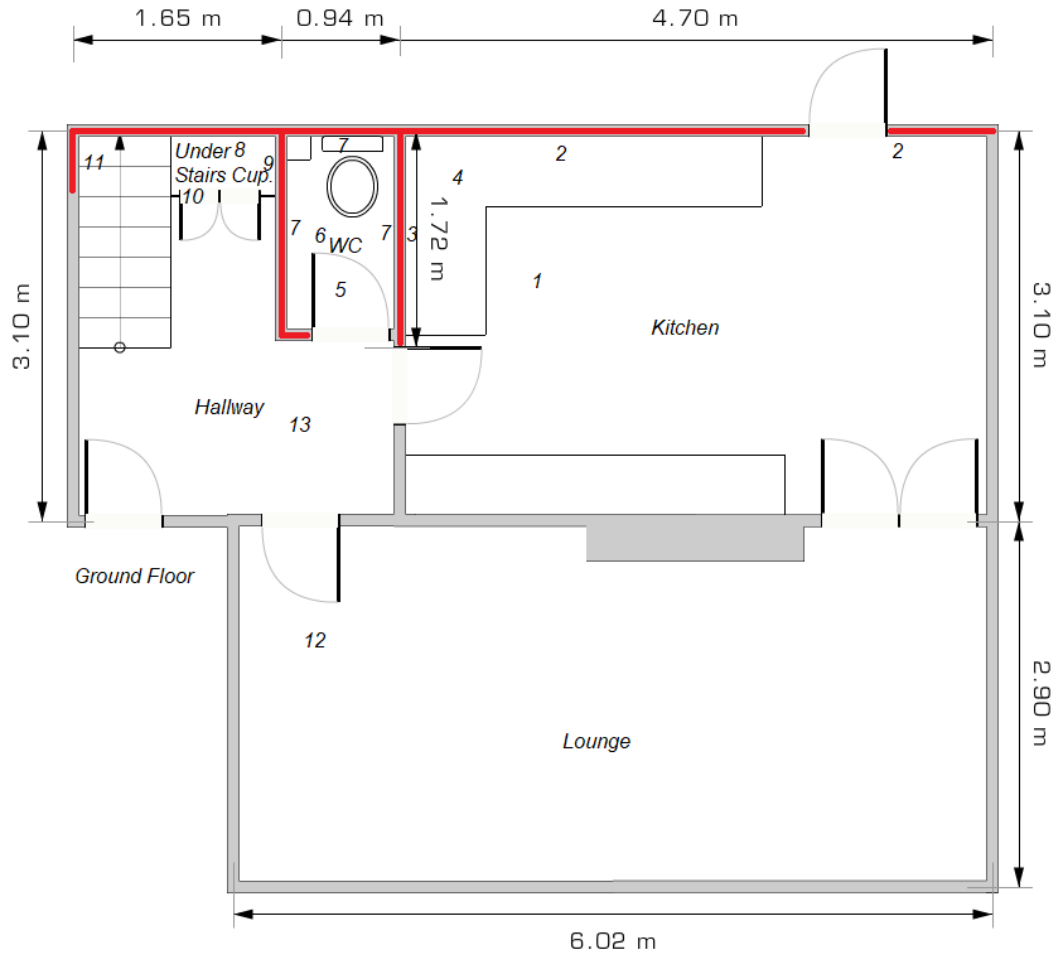
**Affected walls**  
Dimensions are approximate and may slightly vary

The diagrams below show the sample point locations where we took readings to determine how saturated the materials are. Readings in the most affected areas read 999 REL and 100% WME. Wood Moisture Equivalent (WME) is the theoretical %mc (moisture content) value that would be attained by a piece of wood in contact with and in moisture equilibrium with the material under test. The higher the reading, the damper the material is, with 100% WME being the maximum value. As a general rule of thumb, a WME reading should be less than 17.5% WME.
