# Drying a Residential Property in London

CASE STUDY

### THE BRIEF

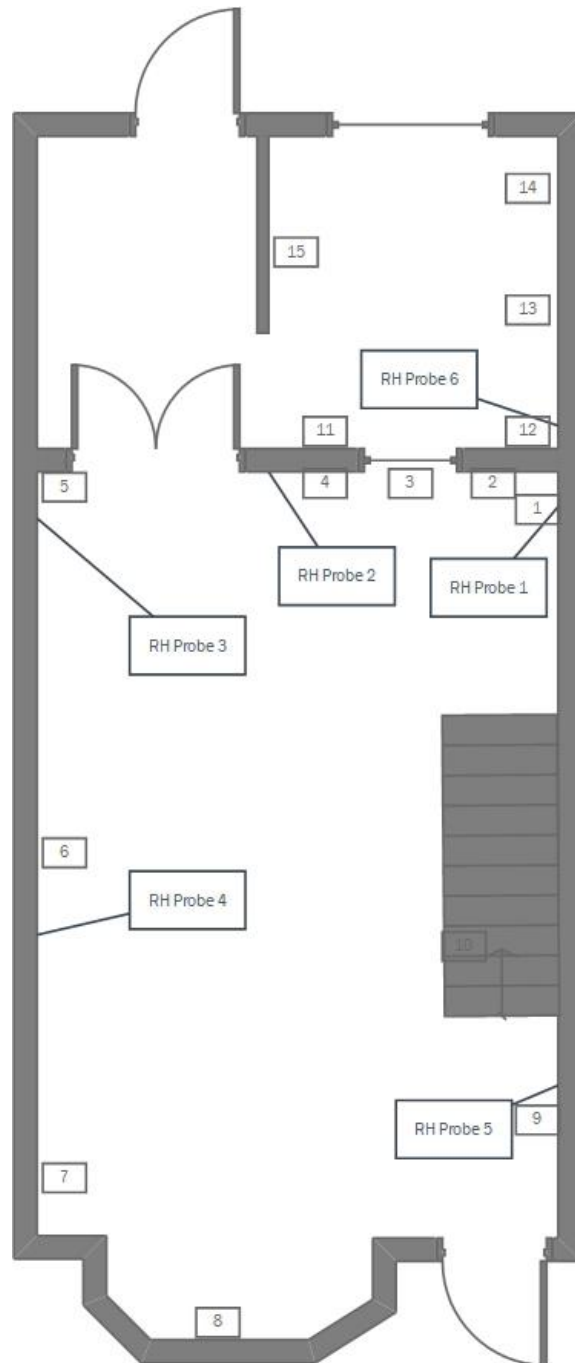
As you can see from the chart below, we recorded very high moisture levels on the walls which have been directly affected by the escapes of water, the walls which are in close vicinity to the mains, and where the water come down into the kitchen following water ingress from the bathroom upstairs. The relative humidity probes located in other walls returned much lower readings.

These results indicate that there is no ongoing damp problem with the walls, even though damp proofing was installed in the form of blackjack and render. The existence of the sand and cement render does not automatically mean that the property is suffering from rising damp; we have seen this installed in many properties above the ground floor with no issues.

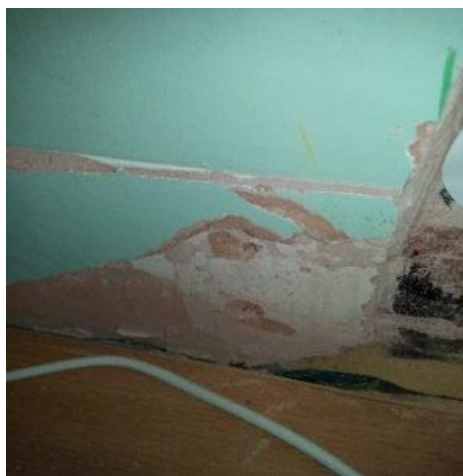
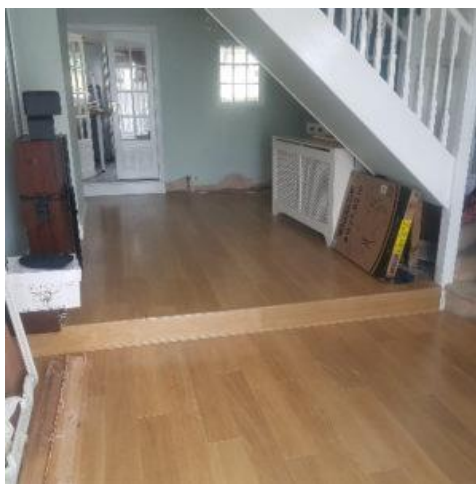
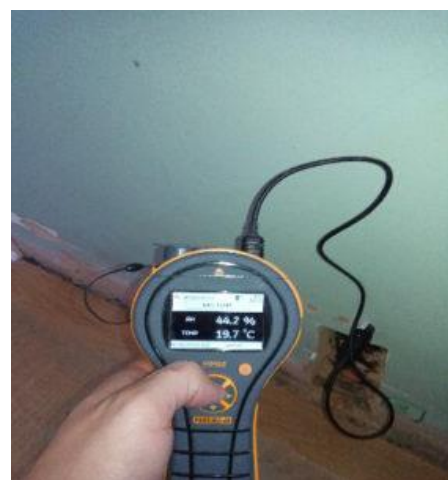
If the moisture evaporates through a permeable surface, these salts will be left behind and form deposits on or within the evaporate surface. Our investigation started by a visual inspection of the walls in the lounge, dining room, and kitchen and we found no signs of salt residue on any of the walls.
