Specialist Drying in Twickenham

CASE STUDY

Twickenham, United Kingdom

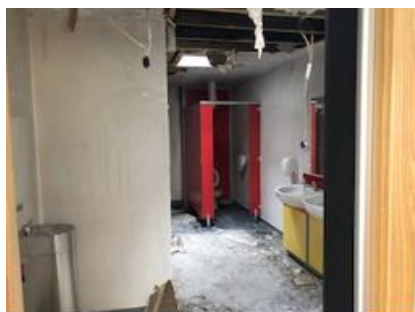
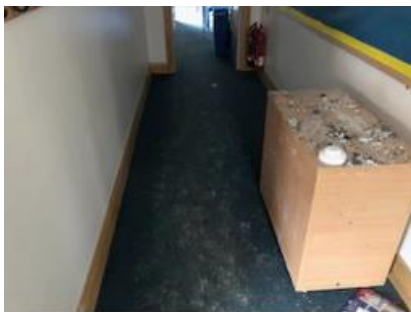
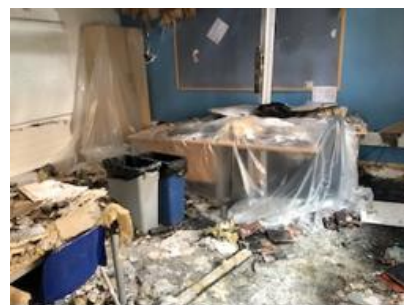
Ceilings collapsed under the weight of the water, with the ceilings in the toilets and club room damaged beyond repair.

The walls (constructed by stud partition and plaster in most rooms, while others are blockwork and plaster) were wet and required drying. The floor slabs were also wet as these areas had been subjected to abnormal amounts of water ingress. The ground floor construction consists of carpet tiles, floor screed, a concrete base, insulation, DPM (damp proof membrane), and hardcore. Some areas also had moisture barriers.

The affected ceilings in the toilets and club room required a complete strip out and all wet carpet tiles needed to be lifted. Skirting board in the affected rooms was also removed, along with affected plasterboard.

Finally, desiccant dehumidifiers were installed, and the areas tented off to target dry the floor slabs in the affected rooms. Desiccant dehumidifiers were also installed in the toilet and the ceiling tented off using plastic sheeting to ensure the most efficient drying environment was created.
