### **Mould Growth Remediation in London**

London, United Kingdom

CASE STUDY

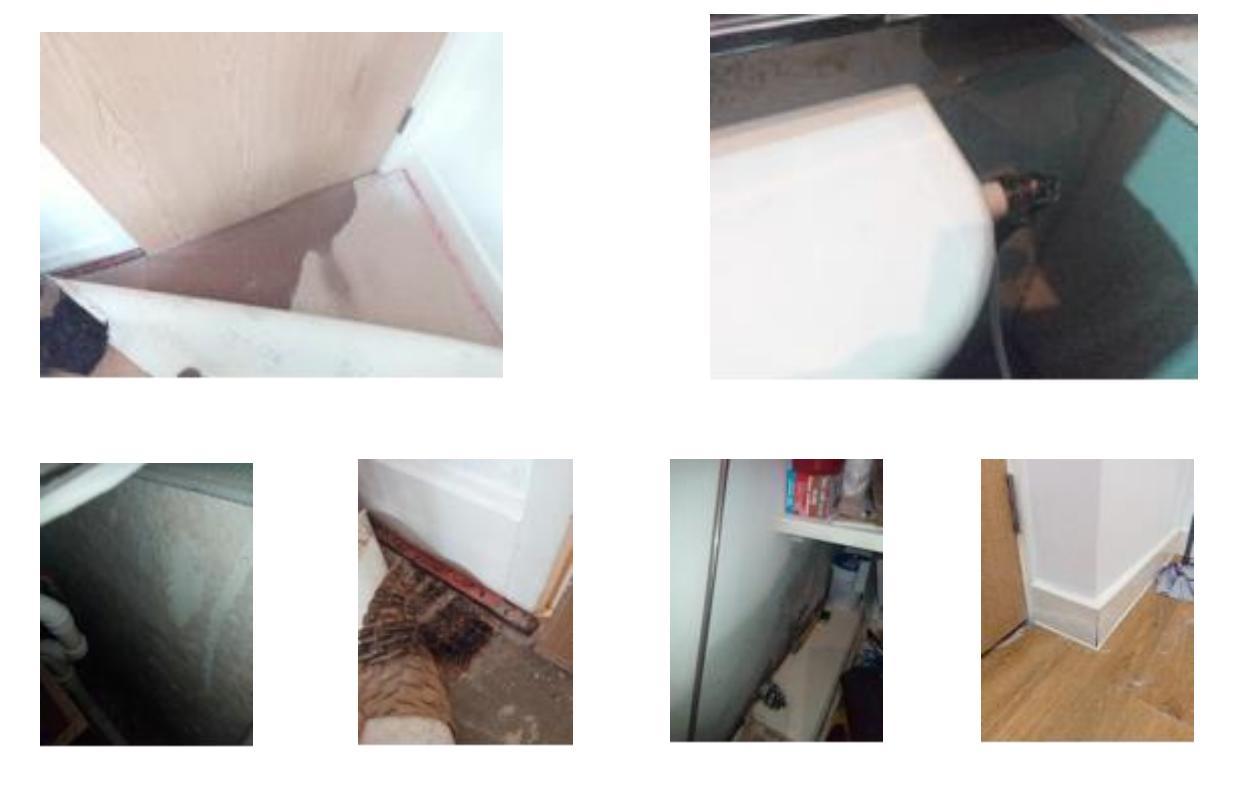
Upon arrival, we took atmospheric readings, which registered as follows:

Relative Humidity	Temperature	Dewpoint	Specific Humidity	Vapour Pressure			
43.1%	29.7°C	15.9°C	11.08g/kg	1.76kPa			
For more information and to see how we can help, call: <b>0808 2394 082</b> 24 HR Speak to a live agent

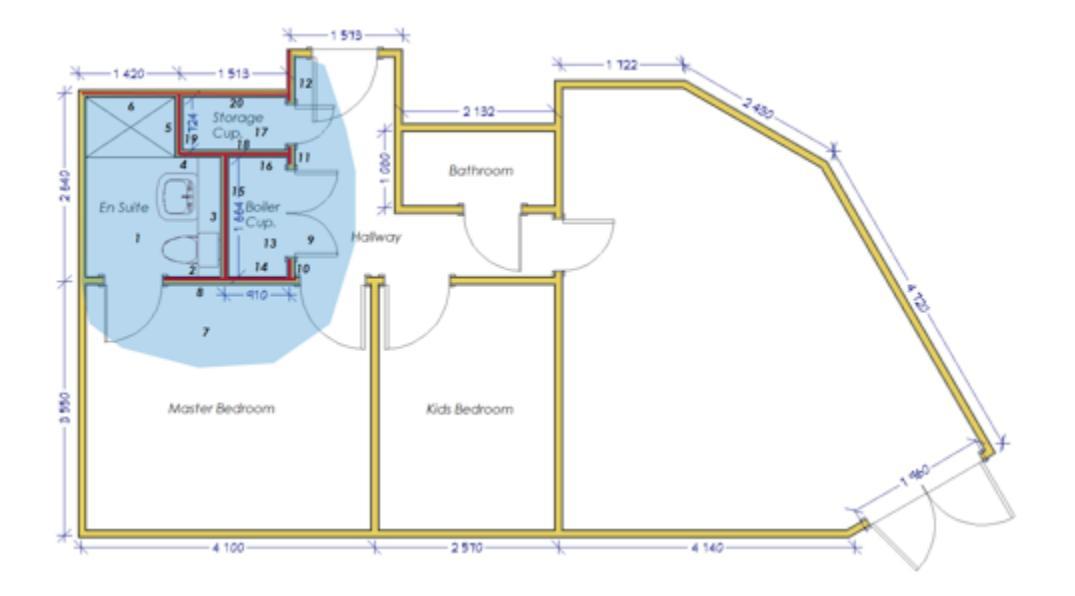
As well as taking atmospheric condition readings, we also completed a moisture survey which gave us the readings as detailed in the chart below.

Sample point	Location / Material	Reading	Sample point	Location / Material	Reading
1	Floor / Tiles	325 REL	11	Wall / Plasterboard	100% WME
2	Wall / Plasterboard	100% WME	12	Wall / Plasterboard	100% WME
3	Wall / Plasterboard	100% WME	13	Floor / Laminate	999 REL
4	Wall / Plasterboard	100% WME	14	Wall / Plasterboard	100% WME
5	Wall / Wall Tiles	999 REL	15	Wall / Plasterboard	100% WME
6	Wall / Wall Tiles	999 REL	16	Wall / Plasterboard	100% WME
7	Floor / Screed	100% WME	17	Floor / Laminate	999 REL
8	Wall / Plasterboard	100% WME	18	Wall / Plasterboard	100% WME
9	Floor / Laminate	999 REL	19	Wall / Plasterboard	100% WME
10	Wall / Plasterboard	100% WME	20	Wall / Plasterboard	100% WME

As you can see from the chart above, we recorded readings of up to 999 REL and 100% WME in multiple locations—these are the maximum readings possible. Such high moisture levels will accelerate the speed of microbial growth in the affected areas and beyond if no action is taken. And as we mentioned earlier, we had noted mould growth in a number of locations already.
