Mould Remediation in Aylesbury, Buckinghamshire

CASE STUDY

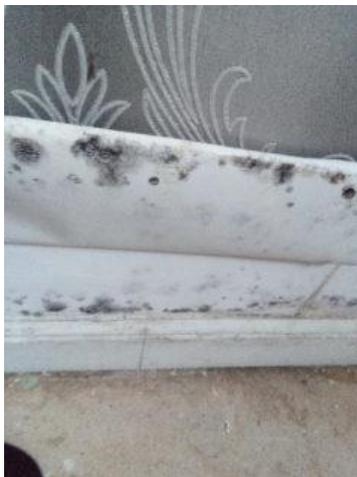
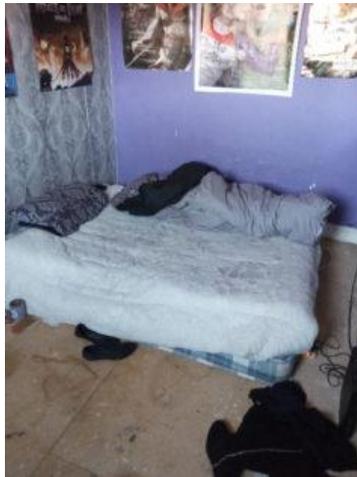
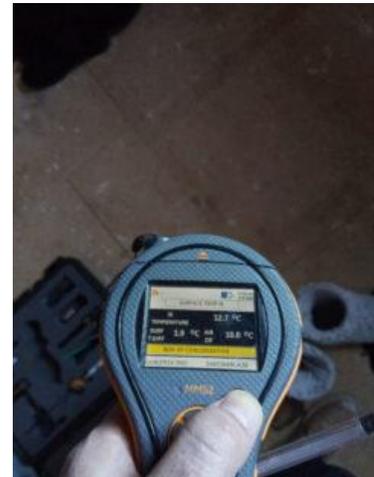
The floor covering in the bedroom had been removed prior to our arrival, exposing visibly stained chipboard flooring. We also noticed mould growth in multiple places across the walls and ceilings. However, on our initial visit, moisture readings were at acceptable levels.

The internal walls recorded at an average of 180 REL, the ceiling at 150 REL, and the floor at 14% WME. A general review of the property pointed to high internal atmospheric moisture levels as the main driver for the reported issue of mould growth.

Firstly, the affected areas were sealed off to prevent mould spores from spreading to previously unaffected rooms. A negative pressure system was installed for the duration of our work to help protect from cross-contamination and remove contaminants from the air.

All affected walls were stripped of wallpaper to expose the mould and facilitate the mould remediation process. All mould-infected surfaces were cleaned and sanitised before the areas were ULV (ultra-low volume) fogged using [Decon 7](#)—a gentle decontaminate which is capable of killing 99.99999% of all viruses, bacteria, and mould.
