# **Mould Removal in West Midlands**

#### **Mould remediation, West Midlands Summary**

Client: Charitable property owner in Stourbridge

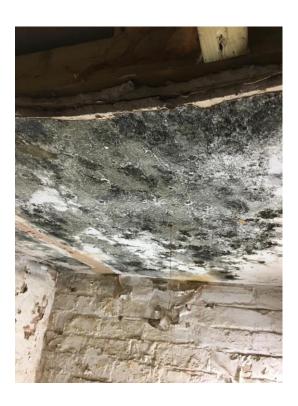
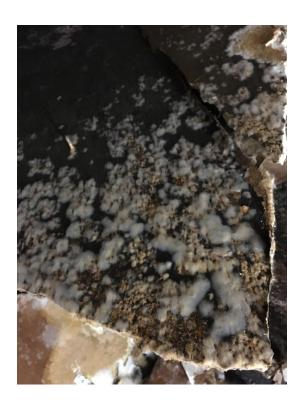
The Ideal team then removed all materials stored in the basement, dismantled and removed the ceiling, and stripped back certain areas of the basement, which revealed mould growth to the internal partition walls and plasterboard finishes. Although these were considered to be secondary damage, our team knew that mould would continue to flourish there, and so these areas were included in the remediation plan.

We then performed our standard 4-stage mould remediation and mould removal programme. Firstly, the team removed surface mould growth with a high-density HEPA-rated vacuum system. We then washed down the plasterboard, plyboard and other affected materials within the basement, and applied a specially formulated fungicidal barrier which kills mould at the root and prevents further growth. The final step in the mould removal process was Ultra Low Volume (ULV) fogging which generates a mist of ULV droplets to remove any airborne particles and eliminate musty smells from interior spaces.

With mould removal in the Stourbridge property completed, the Ideal team performed its regular ozone decontamination process (BioSweep) and installed 2 refrigerant dehumidifiers and 2 turbo air movers as part of a drying programme to stabilise environmental conditions in the property and remove excess moisture from the structure of the building.
