London, United Kingdom

Oil Spill Clean Up in London

CASE STUDY

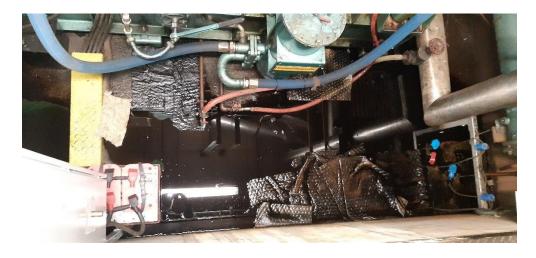
When an engineer working in the boiler room of a bank in London accidentally spilled 80 litres of coolant and 30 litres of oil, they knew that action needed to be taken quickly.

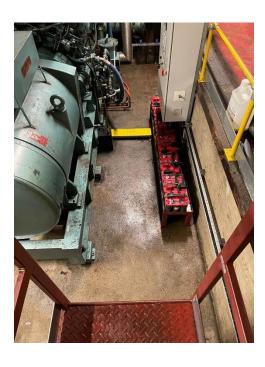
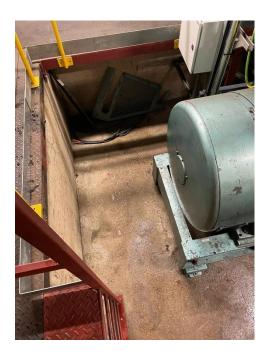
We completed the oil spill clean up in London in just one day, the day after we received a call from the building management company.
