Bugler Developments- Construction Drying

CASE STUDY

Hemel Hempstead, United Kingdom

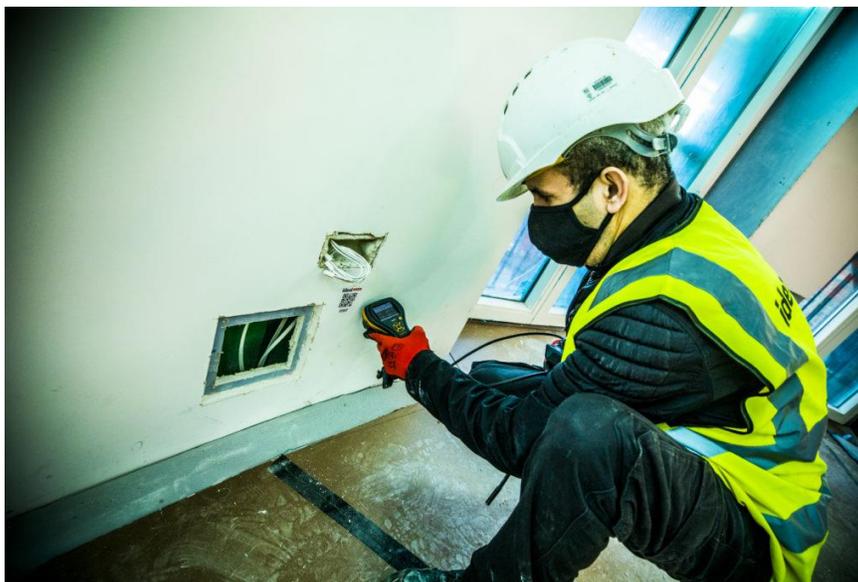
We decided that, in order to get our clients back on track, we would need to go big – bigger than we'd ever gone before. We craned a 750KW industrial boiler onto the top of the building, with a fuel tank, and then we constructed a massive air handling unit. The plan was to drive heat into the building, attacking it stage by stage. This was a unique solution to fit our client's very specific needs, and while it may have seemed slightly excessive and expensive, the highest priority for everyone concerned was speed, and this equipment provided exactly that.

We managed to generate a lot of heat, which we then forced into the ground floor with specialist tubing, and let the heat rise up through our heat exchangers. Once one area of the building was dry, we would move this (incredibly heavy) equipment manually to the next area. This was a constant process throughout the building.

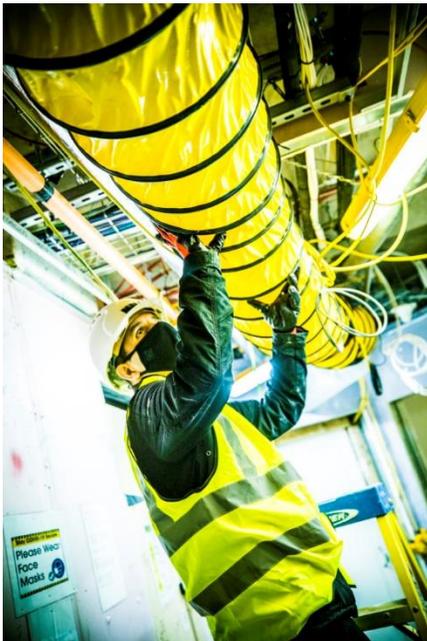
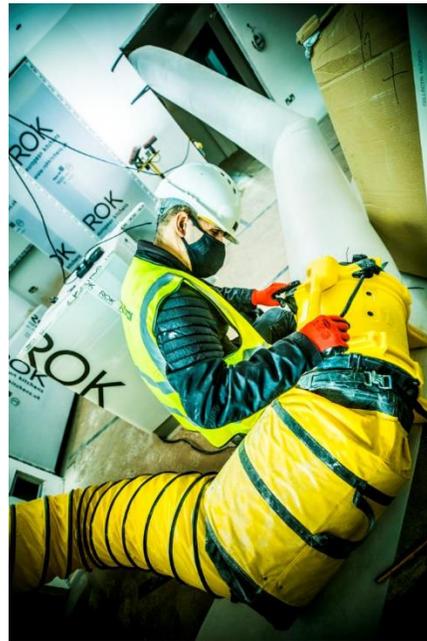
It was important that we recycled as much of the hot air as possible. We erected a vent on the top floor of the building which would suck the heat out of the air and recycle it back into the air handling unit. This was crucial to keep the project as cost effective as possible, while at the same time speeding up the entire process.

All this huge and expensive machinery was obviously integral to the job, but arguably the most critical aspect was the monitoring. In order to track our progress, we had 48 data login points installed throughout the buildings which monitored the relative humidity, the temperature and the moisture in the air. This sophisticated network was operated by just a scan of a barcode, or Data Point, which enabled us to input the data to our system to track the progress.

The entire process became much more difficult when the cold weather became more extreme, bringing snow and thick frosts. We had to act quickly to re-insulate the top of the building by lining sheets to prevent the hot air from escaping. Our commitment to meeting the deadline for our client was all the motivation we needed – nothing would get in our way.
