Fire Restoration for the Co-Op

CASE STUDY

Hurstpierpoint, United Kingdom

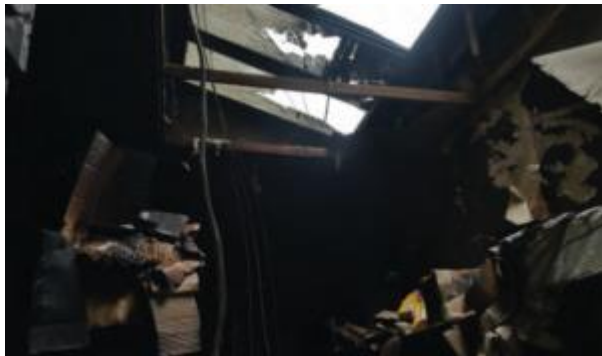
Our initial assessment found that brickwork, electrical equipment, cabling, furnishings, and flooring were all severely damaged. As soot and ash can be extremely acidic and corrosive, it was imperative that we started work as soon as possible to minimise secondary damage.

The extent of the works meant that we would be working in partnership with other service providers, as part of a collaborative approach. This meant the least disruption to the client as work would be completed in the minimal timeframe possible.

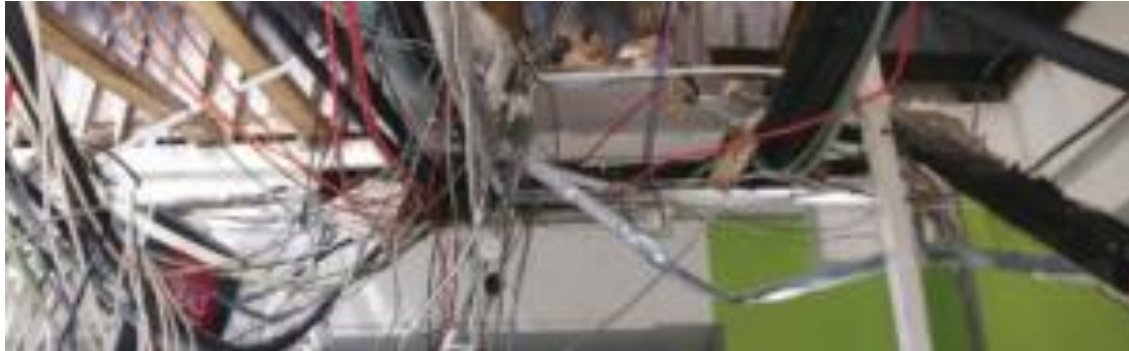
Structural work began at the outset. A lean-to outbuilding was removed and a breeze block CCTV room was also dismantled and removed. The existing checker plate floor covering needed to be lifted and partition walls knocked down. The structure needed to be cut back to the party wall to allow fire-damaged timber to be replaced. All fire-damaged walls were stripped back to bare brick in preparation for soot and smoke removal work.

The fire cleaning method used on this project was Soda Blasting. Soda Blasting removes smoke stains, soot and char quickly and efficiently while acting as a mild deodorizer. This process works by using compressed air coupled with sodium bicarbonate at a relatively low pressure of around 20psi to apply mild abrasive force to affected surfaces. This method brings buildings back to their original state, leaving little to zero trace of a fire.

After completing the Soda Blast treatment, we applied our solvent-free, water-based bonding agent to affected porous surfaces. This creates a permanent, sealed barrier locking in any remaining smoke odour particulates.
