# Medway Maritime Hospital Covid-19 Decontamination

CASE STUDY

Kent, United Kingdom

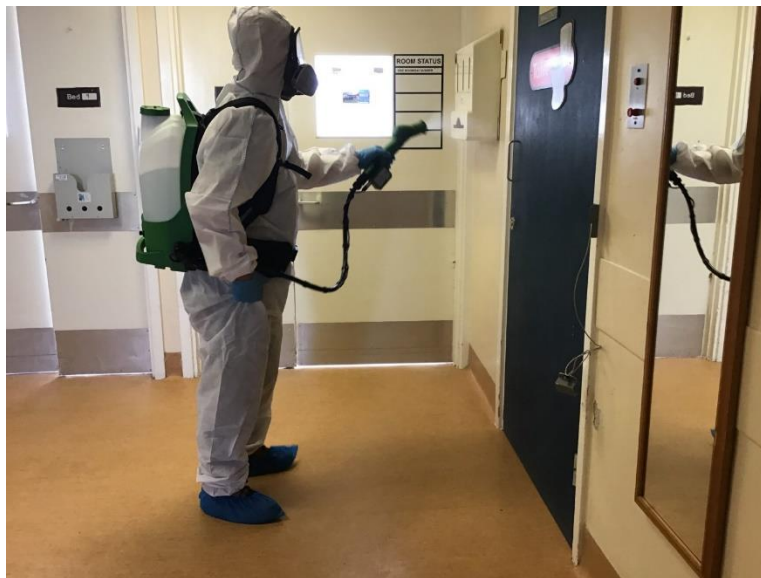
British Disaster Management Association trained technicians using specialist [electrostatic backpack sprayers](#).

The team then completed the disinfection using electrostatic backpack sprayers, which deliver a precise application to help reduce the spread of viruses/bacteria. As part of the multistage decontamination, all wards were decontaminated, together with toilets, a sluice room, medical stores, a staff room, a nursing station and all floors.

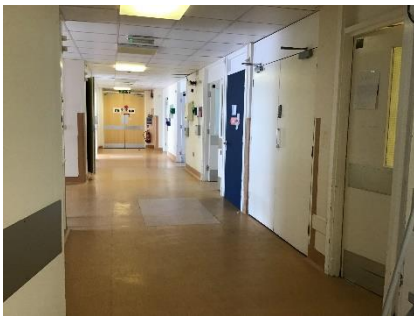
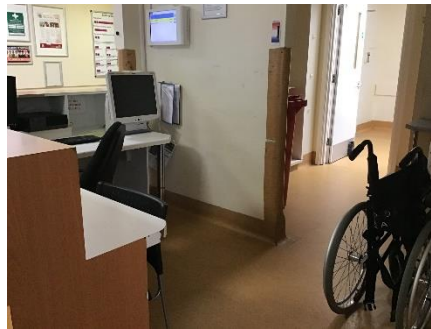
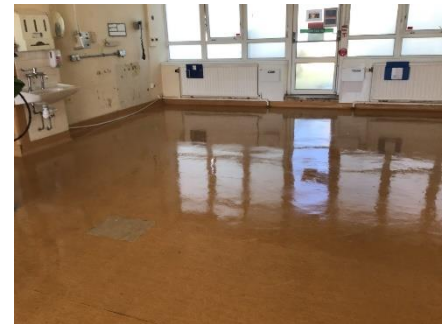
*After decontamination, the result of under 10 RLUs meant all areas were safe for refurbishment to begin.*

Prior to disinfection, our on-site testing showed failures on surface and equipment, with levels of over 1,300 Relative Light Units within the Arethusa Ward, and over 600 RLUs in other areas. Following the decontamination of the ward areas, the Ideal Response team re-tested the areas and all were below 10 RLU's, making the area safe to complete the refurbishment. The areas were signed off by Bauvill's Site Manager Jim Totten, hazardous waste was removed from site, and a decontamination certificate was issued.

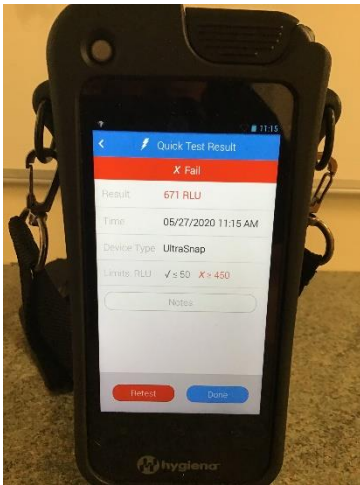
Before result

We use hygiene luminometers (in conjunction with ATP swabs) to take bioluminescence measurements in Relative Light Units (RLUs). This allows us to rapidly assess the level of cleanliness of environmental surfaces in healthcare and other settings. Our goal is always to reduce RLUs to below 150-200 – and we look to reduce levels below 50 RLUs, as was achieved in Medway Maritime Hospital with a result of under 10 RLUs.
