# Morgan Sindall, COVID-19 Decontamination in Sheffield

CASE STUDY

The scope of works specified were to complete a [Covid Decontamination](#) following a positive case to the offices of the Morgan Sindall Trans – Penine Trail Car Park, in Sheffield. There were six offices (measuring approximately 324 square metres) to decontaminate using our specialist [electrostatic decontamination](#) services. Within the specified areas, Ideal Response covered the toilets alongside all welfare areas. We completed live on-site ATP swab testing to prove the areas had been decontaminated, which was recorded and sent in a summary report after the works are completed.

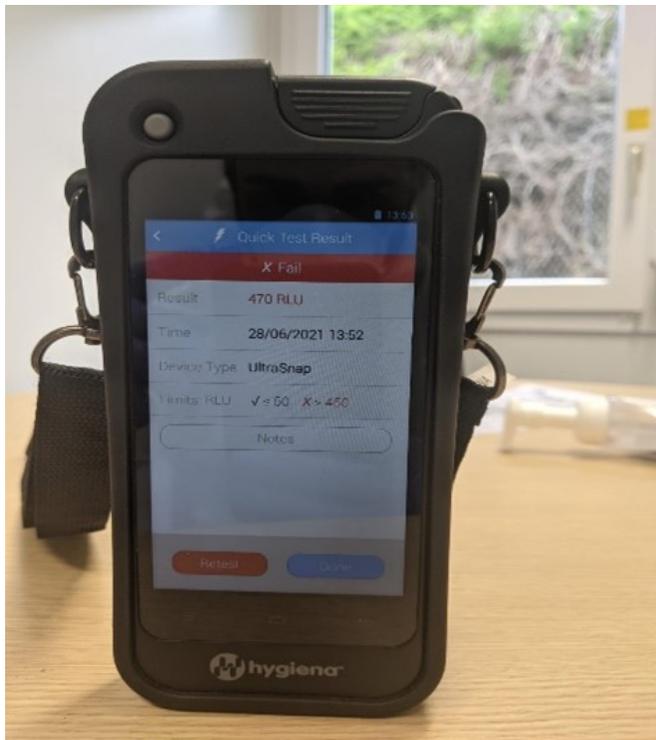
Before: 470 RLU Units

We used an ATP swab tester to measure the relative light units across the surface – and the areas initially measured around four to five hundred units. World Health Organisation guidance recommends a level of no more than 50 relative light units, and the aim of the works are to ensure the reduction of the bacterial count. We used a specialist cleaning solution applied by an electrostatic sprayer to reduce the bacterial count – and then swabbed on the finish to check those areas were reduced to the targeted levels.

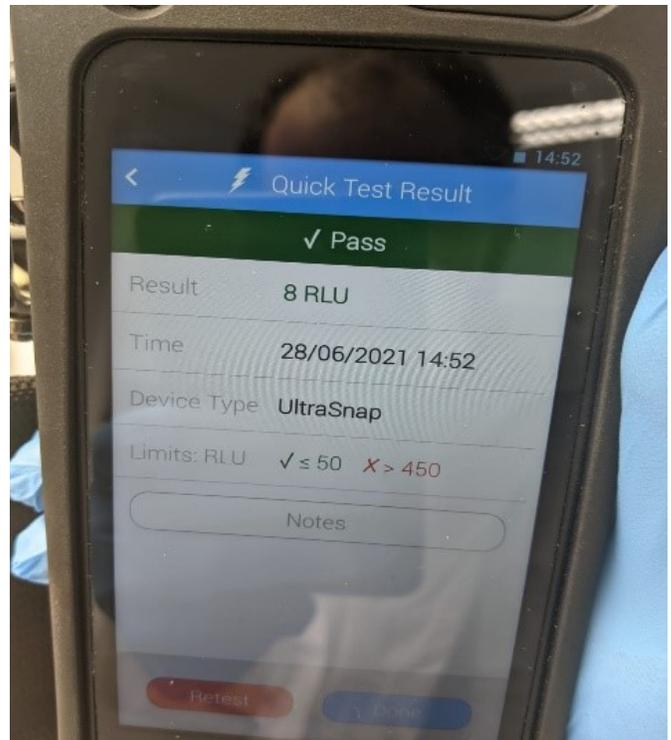
After: 8 RLU Units

Throughout the decontamination – the swab testing completed by the Ideal Response lead technician demonstrates the areas are confirmed ready to return the office staff the following morning and giving the confidence that the office touch points and surfaces were completed to a high level.
