Oil Spill in Rainham, Kent

CASE STUDY

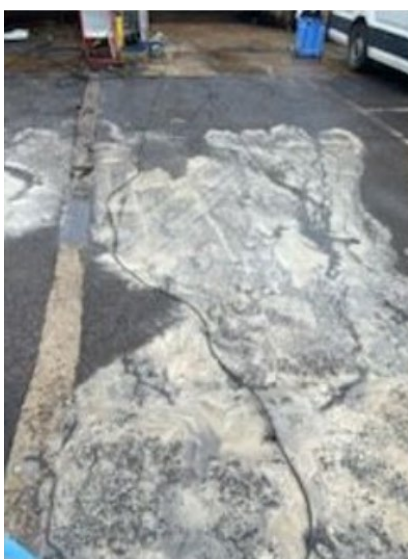
As you can see from the photos below, the result was emphatic – all of the oil was completely cleaned up and a dangerous and the unsightly problem was completely removed.

Phase 1: In order to remove the standing oil, we deployed our 'wet vac' vacuum. This is a vacuum that is specifically designed to remove liquid spills. We worked on the affected area until we were sure that we had cleared up as much of the liquid as was possible by this means.

Phase 2: We decided to combat these areas by applying OT8 to the affected areas. OT8 is a blend of biodegradable surfactants that acts as a detergent to break down the stubborn sections of the oil spill. It is an environmentally-friendly agent, so we can use it safe in the knowledge that we will not be causing any harm to the environment – it is commonly used on oil spills on roads as it doesn't cause any surface erosion.

This is then rinsed with water, and so that no oil is washed down drains, we use the wet vacs again to Hoover up all of the water and oil remnants. This is then disposed of responsibly.
