Grade 2 Listed Building: Fire, Flood and Drying for The Law Society

CASE STUDY

London, United Kingdom

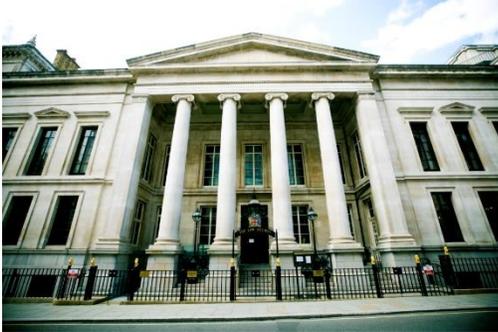
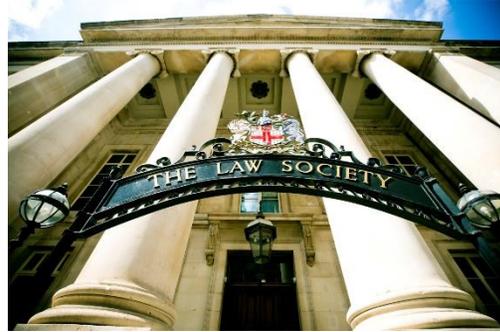
This was highlighted in February 2020 when a fire started on the top floor of The Law Society Headquarters on Chancery Lane, a Grade 2 listed building. The fire, thought to have been caused by an electrical fault, had soon destroyed the roof of the building, as well as an entire staircase between the 3rd and 5th floors.

We needed to get all of the damaged furniture, computers, office equipment out of the property as a priority. Only once all of this was removed would we be able to tackle the other aspects of the cleaning job. We also had to take up all of the floor coverings that had been damaged, as well as anything that posed an immediate risk to the health of the workers, for example hanging plasterboard, or loose fixtures.

This is where we tackled the fittings and fixtures, removing any that were irreparably damaged. This included plasterboards, skirting boards, door frames, even walls and stud walls.
