# Mould Removal in Grade II Listed Property

CASE STUDY

Durham, United Kingdom

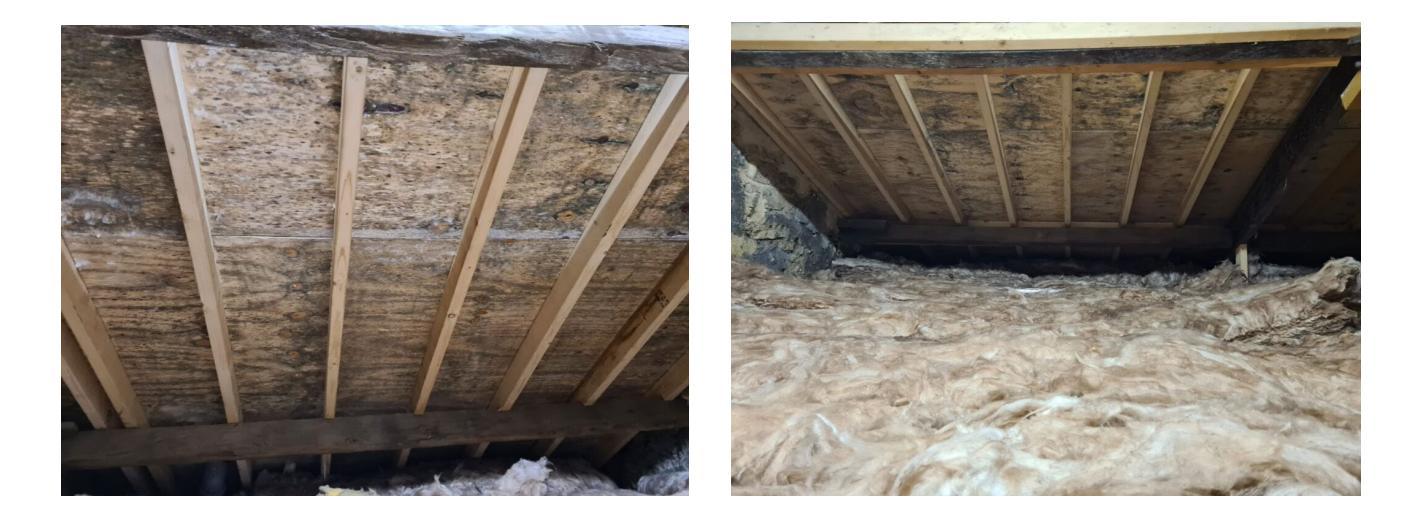
Even with the mould now removed, we knew that our job was far from over. We know that mould is a by-product of a problem within the property – damp. We needed to fix the cause of the problem, otherwise, it would just keep recurring. A drying programme was initiated.

We installed 4 Dri-Eaz 1200 dehumidifiers, one for each property, for an initial two week period. This was to prevent any regrowth before the mould in the loft could be addressed. We continued to monitor the progress of the drying, and it was decided that an extended programme would be required.
